Manhole Inspection Summary

Manhole # S47A1_006MH

Insp Date: **2/5/09 12:07 PM**

Location Address: **2025 mcomas st**

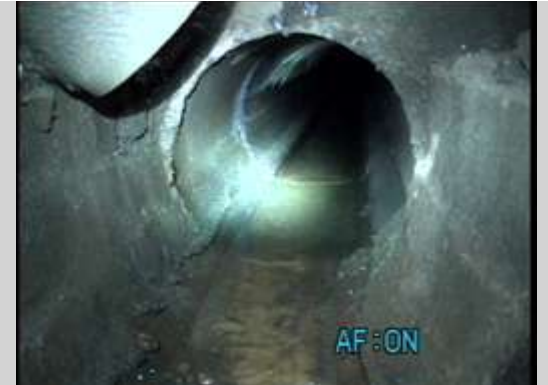
12 O'Clock Outflow

12 in. Circular Gravity Sewer
Pipe Out @ 12 O'Clock

Pipe Material: **Clay** ☐ Pipe Lined

Invert Depth: **13.00** (ft.) Flow Characteristics: **Slow**

Infiltration: **None** Pipe Seal Cond: **Unknown**

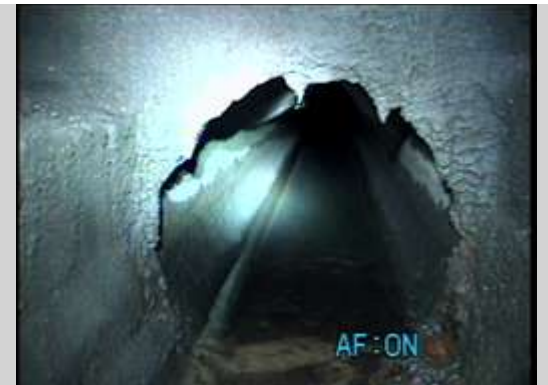
5 O'Clock Inflow

12 in. Circular Gravity Sewer
Pipe In @ 5 O'Clock

Pipe Material: **Clay** ☐ Pipe Lined

Invert Depth: **12.92** (ft.) Flow Characteristics: **Slow**

Infiltration: **None** Pipe Seal Cond: **Unknown**

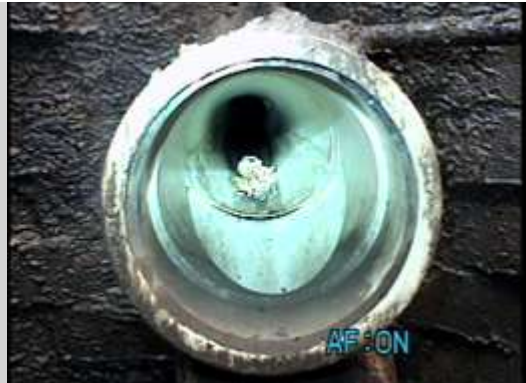
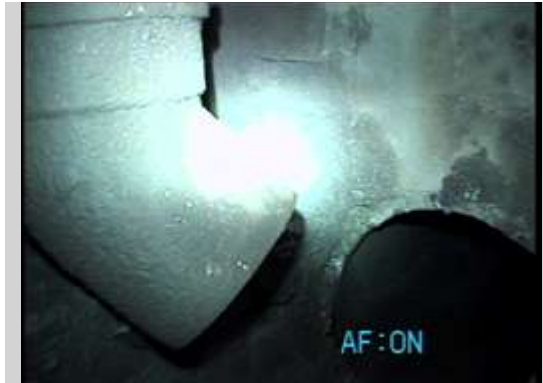
11 O'Clock Inflow

8 in. Circular Gravity Sewer

Pipe In @ 11 O'Clock

Drop In @ 11 O'Clock

Pipe Material: **PVC** ☐ Pipe Lined

Infiltration: **None**

Drop Condition: **Open**
